# Residual Risk

*An Account of Events in Nuclear Power Plants  
Since the Chernobyl Accident in 1986*

April 2007

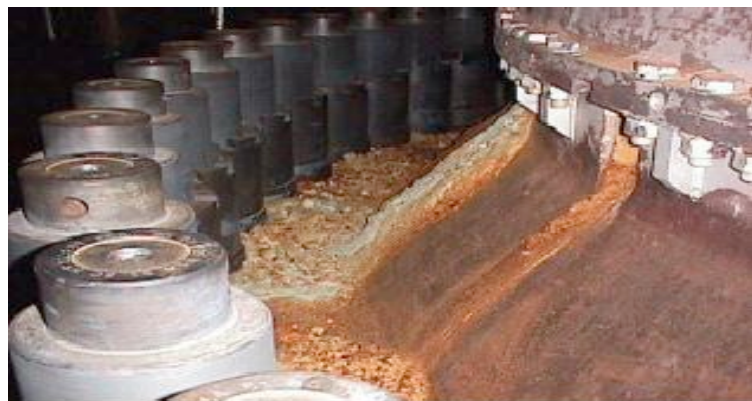
Rust-laced boric acid 'river' flowing through inspection ports on the reactor head and down onto the reactor flange during the refueling outage in 2000.

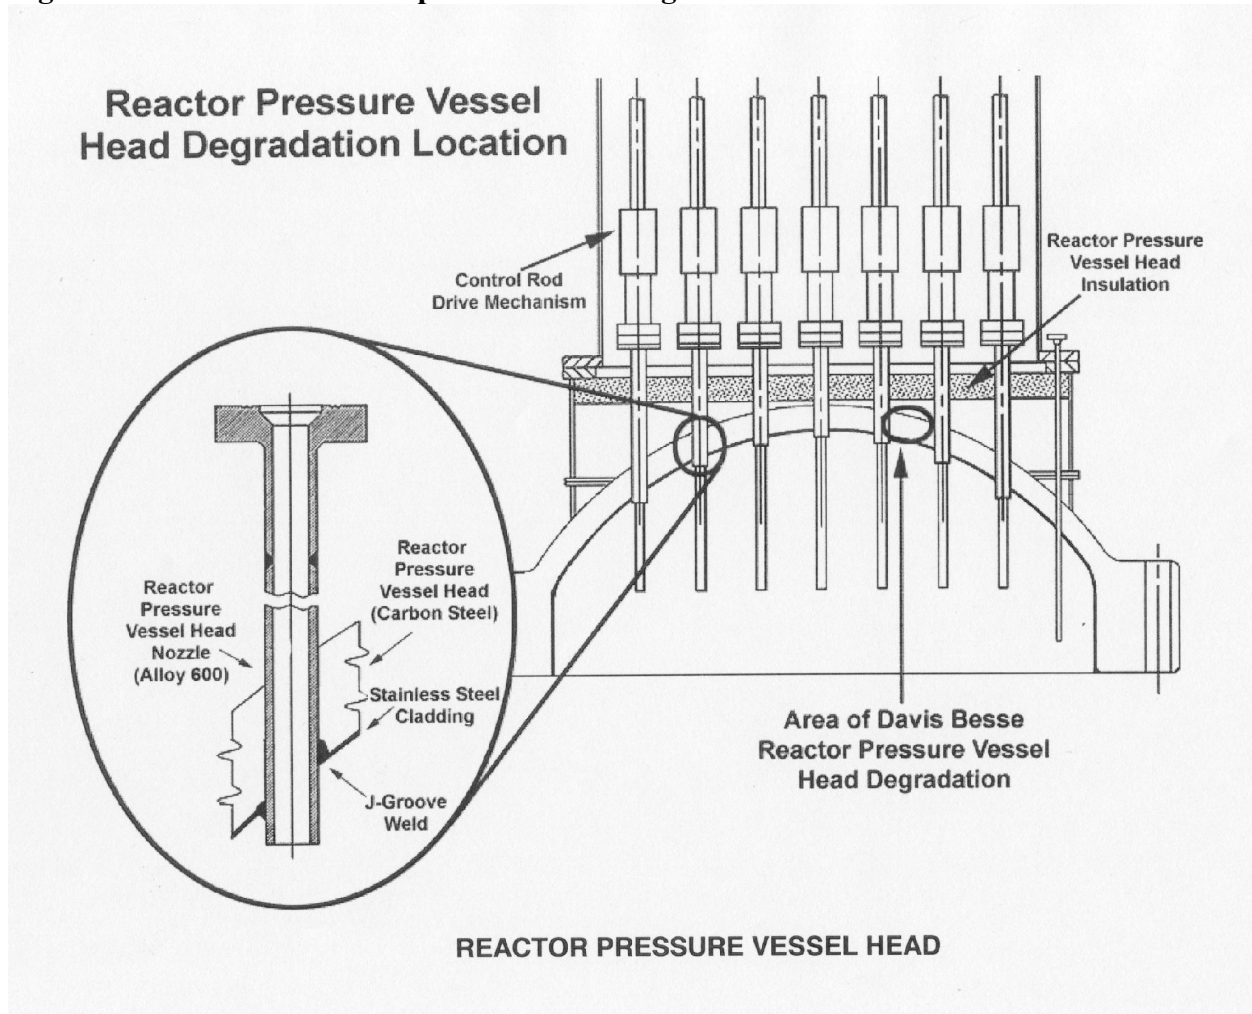
**Figure 8: Davis Besse reactor pressure vessel degradation**

When the leaked water evaporated, it left behind dry boric acid crystals. Boric acid is very corrosive to carbon steel. It began eating through the carbon steel head. By 2002, there was a pineapple-sized hole in the head. The boric acid had completely eaten through the 150mm thick carbon steel wall to expose the stainless steel liner. The liner was applied to the inner surface of the carbon steel reactor vessel and head for protection against the corrosive borated water. The liner was not intended to be pressure-retaining, but for years it was the only barrier preventing a loss of coolant accident. As boric acid widened the hole, the stress loading of the liner increased. A government study estimated that the hole would have widened to the point where the liner ruptured in another 2 to 11 months of operation by Davis-Besse. Because Davis-Besse ran 18 months between refueling outages, had the damage been missed during the 2002 outage, it seems likely that a loss of coolant accident would have occurred.

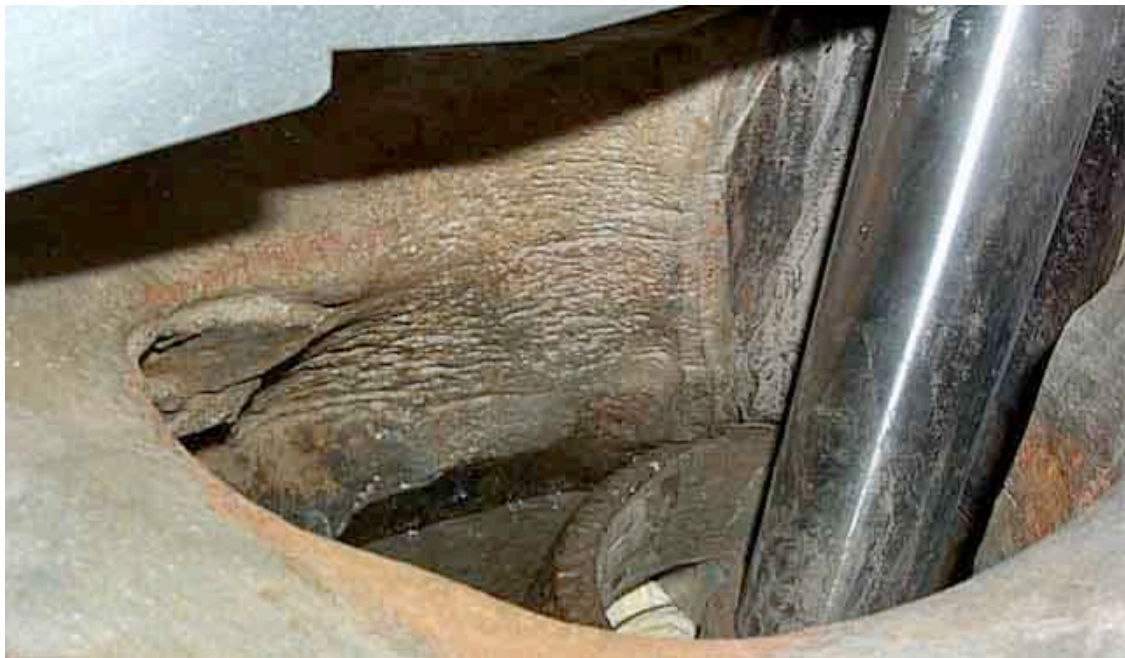
Had the 5mm stainless steel liner ruptured, a hole with a diameter of approximately 250mm would have created a medium-sized loss of coolant accident. While Davis-Besse was equipped with emergency systems to mitigate such an accident, these backup systems were also found to be impaired. The worst problem involved the containment sump used during the second phase of accident mitigation. In the first phase, emergency pumps transfer water from a large storage tank adjacent to the containment building into the reactor vessel to compensate for the cooling water pouring out the 250mm diameter breach. The water pouring out of the reactor drains to the bottom of the containment building where it collects in a concrete pit called the containment sump. Before the storage tank empties in about 30 to 45 minutes, the operators realign the emergency pumps to take water from the containment sump and send it to the reactor vessel. Workers found that the debris created by water jetting out through the hole (e.g., insulation and coatings scoured off piping and components) in addition to pre-existing debris inside containment (e.g., paint applied to the inner surface of the containment dome

*The large hole in the reactor vessel head around the vessel head nozzle.*

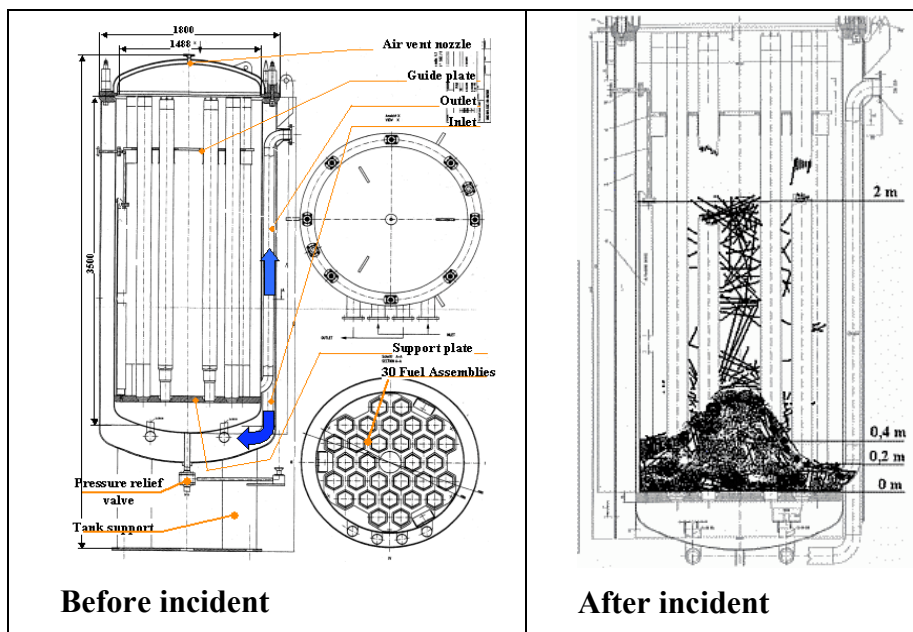
**Figure 9: Paks Fuel Cleaning Tank Before and After the Incident**

- Location of a pressure relief valve at the bottom instead at the top of the tank, which led to malfunctioning of the cooling function;
- Inadequate sizing of the submersible pump, whose redundancy and back-up system was also inadequate. The low-capacity pump had to operate for several hours after completion of the cleaning which was clearly beyond its design specifications;
- The tank design did not assure precise positioning of the bottom end of the fuel assemblies in the cleaning tank;
- Only one fuel guide plate in the cleaning tank was utilized, which cannot assure proper alignment of the fuel assemblies. The possible bypass flows around the fuel assemblies – thus not fulfilling its cooling function – were not fully taken into account;
- Instrumentation, trend recording and alarms provided to detect off normal conditions were inadequate.

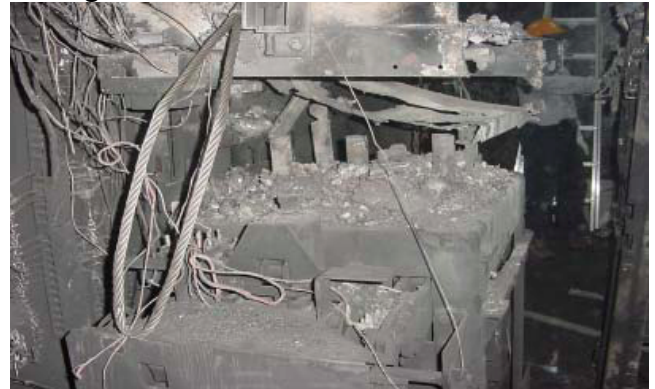
Damaged Breaker

**Figure 11: Breaker Damage at Maanshan During Station Blackout**

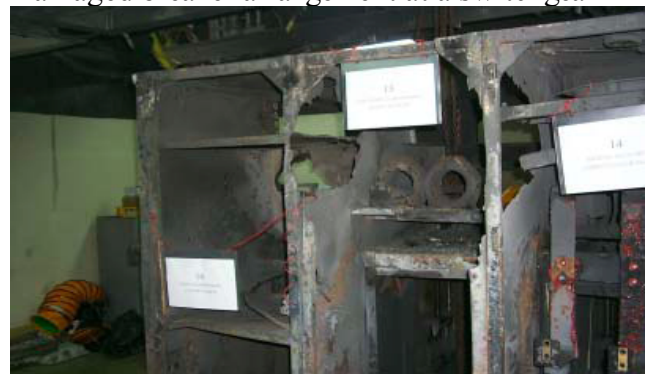
Damaged breaker arrangement at a switchgear
